Manhole Inspection Summary

Manhole # S31OO1016MH

Insp Date: **4/14/07 10:12 AM**

Location Address: **4501 CHARLES ST**

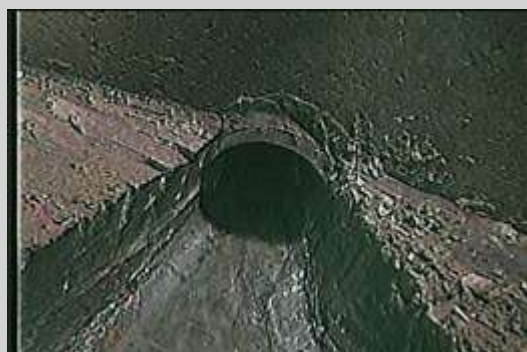
Pipe Out @ 12 O'Clock

8 in. Circular Gravity Sewer

Pipe Material: **Clay** ☐ Pipe Lined

Invert Depth: **9.93** (ft.) Flow Characteristics: **Fast**

Deposits: ☒ None ☐ Mud ☐ Sludge ☐ Debris ☐ Grease

Infiltration: **None** Pipe Seal Cond: **Unknown**

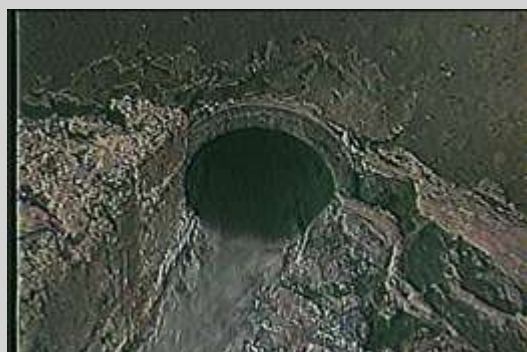
Pipe In @ 5 O'Clock

8 in. Circular Gravity Sewer

Pipe Material: **Clay** ☐ Pipe Lined

Infiltration: **None** Pipe Seal Cond: **Unknown**
